Technical Bulletin: AirLink XR Series GNSS Issue

DATE ISSUED:	26-July-2023		
ISSUED BY:	Sierra Wireless Enterprise Solutions Product Management		
PRODUCTS AFFECTED:	XR80, XR90		
VARIANTS AFFECTED:	SKU	DESCRIPTION	STATUS
	1104722	XR90 Single 5G Global	UNAFFECTED
	1104723	XR90 Dual 5G Global	AFFECTED
	1104785	XR90 Single 5G North America	AFFECTED
	1104786	XR90 Dual 5G North America	AFFECTED
	1104787	XR80 5G Global Wi-Fi	AFFECTED
	1104789	XR90 5G North America Wi-Fi	AFFECTED
	1104791	XR80 5G Global non-Wi-Fi	AFFECTED
	1104793	XR90 5G North America non-Wi-Fi	AFFECTED
	1104878	XR80 LTE Global Wi-Fi	AFFECTED
	1104879	XR80 LTE North America Wi-Fi	AFFECTED
	1104880	XR80 LTE Global Wi-Fi	UNAFFECTED
	1104881	XR80 LTE North America non-Wi-Fi	UNAFFECTED
	1104757	XP-5G Cartridge	UNAFFECTED
FOR DISTRIBUTION TO:	Customers & Authorized Resellers		
SUMMARY:	<p>Sierra Wireless has determined that a small number of XR routers may contain a Global Navigation Satellite System (GNSS) hardware issue.</p> <p>The symptom is a flashing red GNSS LED on a powered router that is connected to a known-good active GNSS antenna. Note: A flashing red GNSS LED normally indicates a GNSS antenna installation issue, b

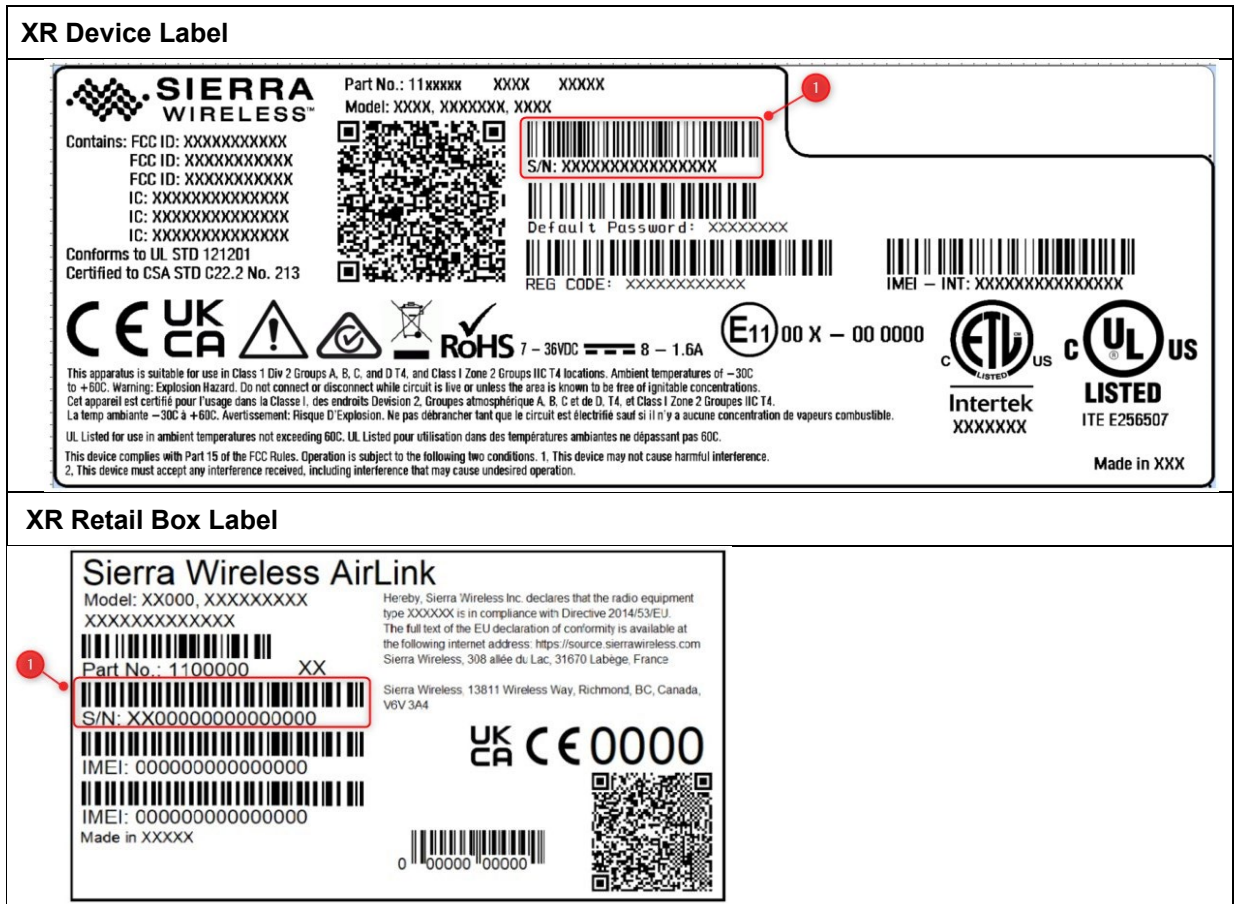
XR router serial numbers are printed on the router device label and on the router retail box label at location ① in the diagrams below.

- Date code: The 3rd through 5th characters “NNN” indicate the date code.
- Factory code: The 4th character “F” from the right is the Factory Code:
 - e.g., xxNNNxxxxxxxxFxxx
 - contains NNN date code
 - contains F Factory Code
 - Affected routers have Factory code F and a date code lower than 320
 - e.g., xx320xxxxxxxxFxxx and higher (Unaffected)
 - e.g., xx319xxxxxxxxFxxx and lower (Affected)

- Return your router for replacement by referring to **REPLACEMENT PROCESS**, or
- Verify the GNSS is working by referring to Appendix B

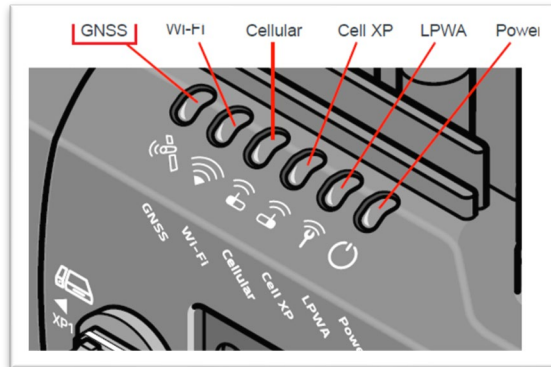
The GNSS LED is the leftmost LED. The LED states discussed below require the GNSS to be enabled and an active GNSS antenna connected to your router.

The GNSS LED is designed to indicate a detected GNSS antenna connection issue. On affected routers, the GNSS LED flashes red fast or slowly without an actual GNSS error. This is the condition this procedure is verifying.

Step 4: Affected routers must be returned for replacement. Note that due to the nature of the manufacturing issue, functioning XR routers will remain functional in the future.
