Product Security Advisory: AirLink Router Security Advisory

Sierra Wireless Advisory: SWI-PSA-2023-003 ([link to latest version](#))

Date: June 22, 2023

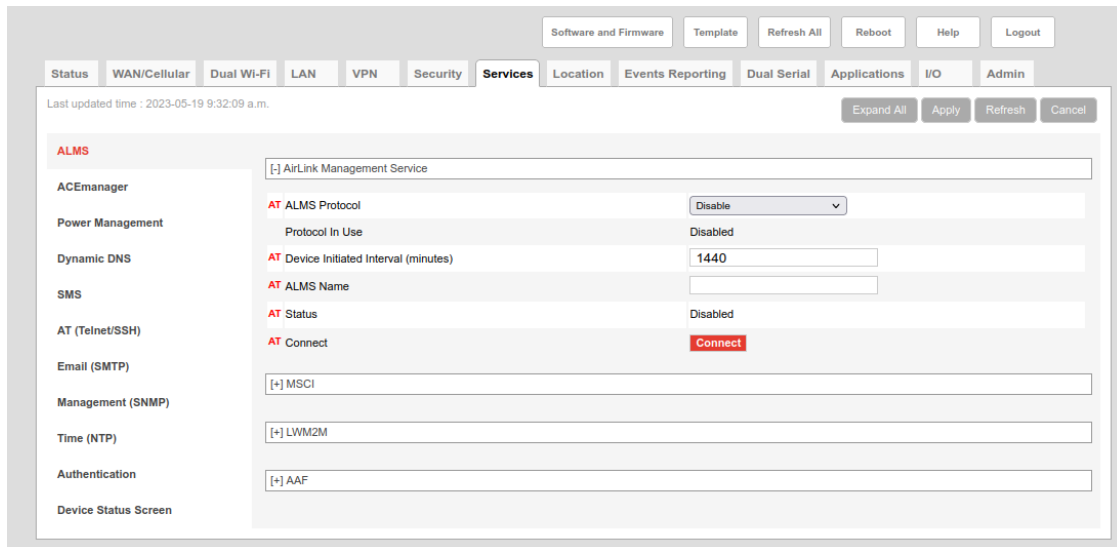
1. ALEOS-based Devices (AirLink ES450, GX450, MP70, RV50, RV50x, RV55, LX40, & LX60)

The ALMS / AirVantage platform is vulnerable to an unauthorized attacker, with relevant registration information, registering unregistered devices on the ALMS / AirVantage platform when the legitimate owner has not registered the device or disabled the AirLink Management Service protocol on the devices. This could enable an attacker to configure and manage an unsuspecting user's devices.

In AceManager update the “ALMS Protocol” configuration setting in Services > ALMS tab to “Disable” and apply the settings.

NOTE: This setting will need to be updated if ALMS support is desired.
