>> MG90 4.0.5 Release Notes

MG90 4.0.5 is for MG90 routers.

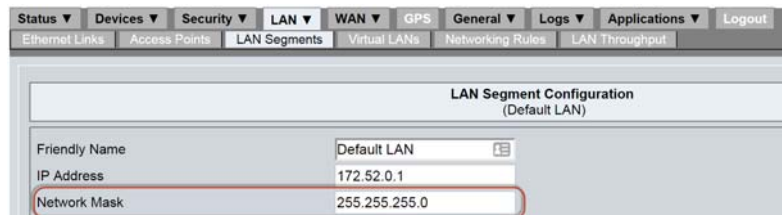
GPS/GNSS LAN UDP Broadcast

The broadcast address is calculated incorrectly for LAN segments defined with a /29 netmask (255.255.255.248) for local sentence forwarding.

To avoid this issue, set the Network Mask in each of those LAN segments (LAN > LAN Segments) to 255.255.255.0.

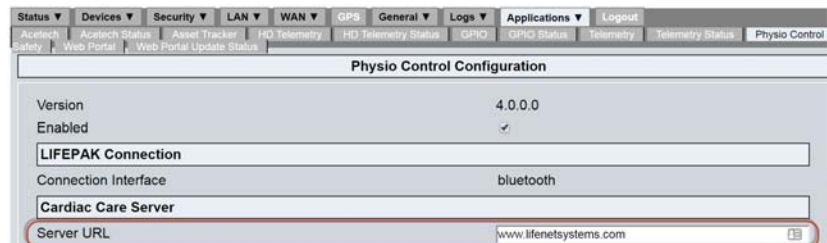
- Physio Control LIFEPAK—The default Server URL in the LCI's Physio Control Configuration screen is incorrect.

To resolve this issue, manually set the Server URL in Applications > Physio Control to www.lifenetsystems.com.
