>> MG90 4.0.4 Release Notes

MG90 4.0.4 is for MG90 routers.

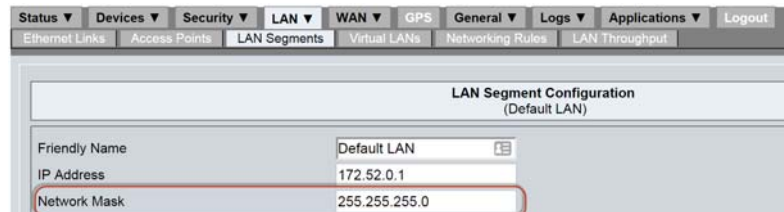
The broadcast address is calculated incorrectly for LAN segments defined with a /29 netmask (255.255.255.248) for local sentence forwarding.

To avoid this issue, set the Network Mask in each of those LAN segments (LAN > LAN Segments) to 255.255.255.0.

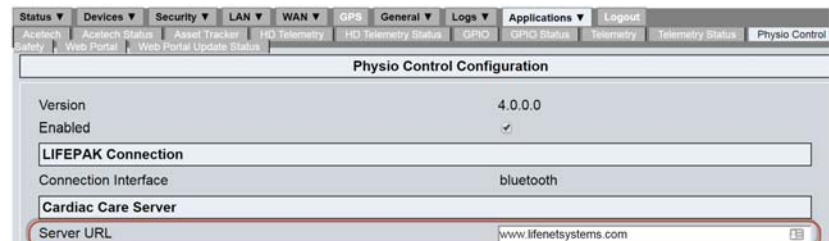
- Physio Control LIFEPAK—The default Server URL in the LCI's Physio Control Configuration screen is incorrect.

To resolve this issue, manually set the Server URL in Applications > Physio Control to www.lifenetsystems.com.
