## AirLink OS 3.1

### RELEASE NOTES

## About AirLink OS 3.1

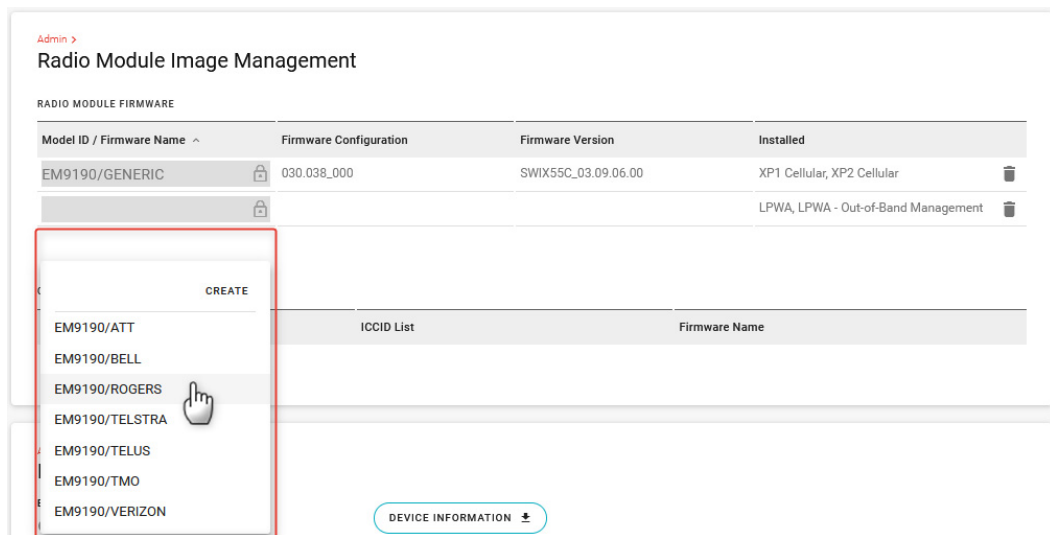
After upgrading from AirLink OS 3.0 to 3.1, the Cellular LED may flash red even though the Cellular interface is connected and passing traffic. This is caused by a radio module firmware mismatch after the update. AirLink OS 3.1 adds new radio module firmware for Canadian carriers.

To restore normal LED operation:

- Manually add your radio module/carrier name to the Radio Module Firmware table at Admin > Radio Module Firmware Image Management.
  - Click an empty field in the Model ID/Firmware Name column and then select your radio module/carrier name, as shown in the example below.
- Repeat the upgrade to AirLink OS 3.1. The router will reboot and apply the correct radio module firmware.
