AirLink OS 4.0

RELEASE NOTES

About AirLink OS 4.0

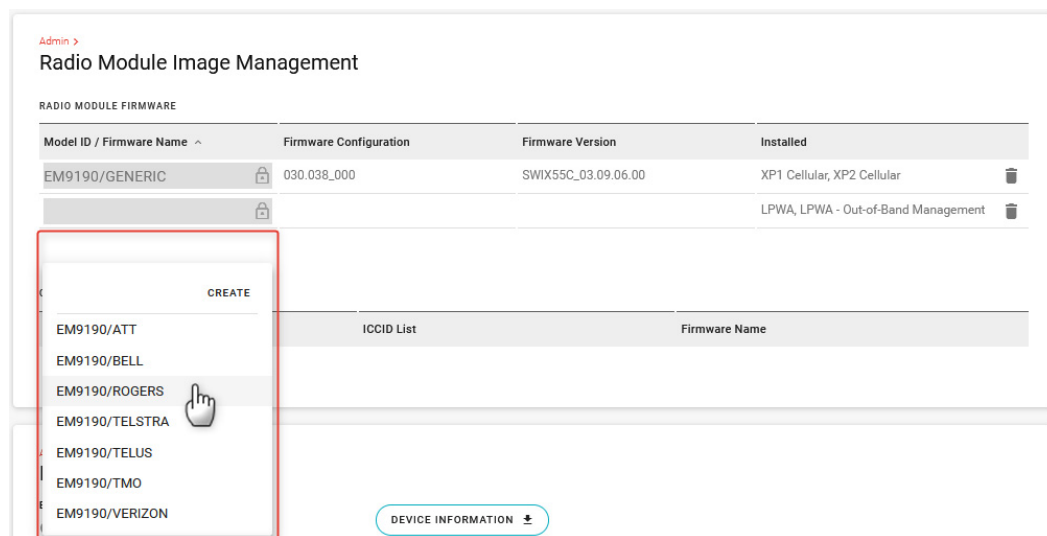
After upgrading from AirLink OS 3.0, the Cellular LED may flash red even though the Cellular interface is connected and passing traffic. This is caused by a radio module firmware mismatch after the update. AirLink OS 3.1 adds new radio module firmware for Canadian carriers.

To restore normal LED operation, manually add your radio module/carrier name to the Radio Module Firmware table at Admin > Radio Module Firmware Image Management. Click an empty field in the Model ID/Firmware Name column and then select your radio module/carrier name, as shown in the example below. Finally, upgrade AirLink OS to the desired version again.
