MGOS 4.3.0.1 Release Notes

MGOS 4.3.0.1 is for MG90 Series routers.

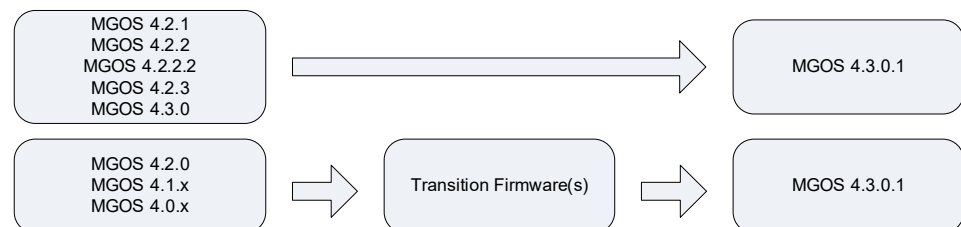
- Upgrade path—A minimum version of MGOS 4.2.1 is required to upgrade directly to this release. For MG90s installed with MGOS 4.2.0 (or earlier), transition releases are required before upgrading to this release. The required transition releases depend on the MG90's currently installed firmware.

To identify the transition firmware required, refer to [Product Bulletin: Upgrading to MGOS 4.2 or Later—Updated 26 Nov 2018](#).

Important: *“Transition Firmware(s)” (MGOS 4.1.2.2 and MGOS 4.2.0.2) are only intended as stepping-stone firmware in the upgrade path to MGOS 4.3.0.1 and are not intended for long-term use. Failure to install the required transition firmware prior to upgrading to MGOS 4.3.0.1 via the AMM will result in an upgrade failure, and can require a USB-stick install to recover.*
