## MGOS 4.4.2.2

### RELEASE NOTES

## About MGOS 4.4.2.2

MGOS 4.4.2.2 is specifically for customers with GPS location applications that use TAIP messaging.

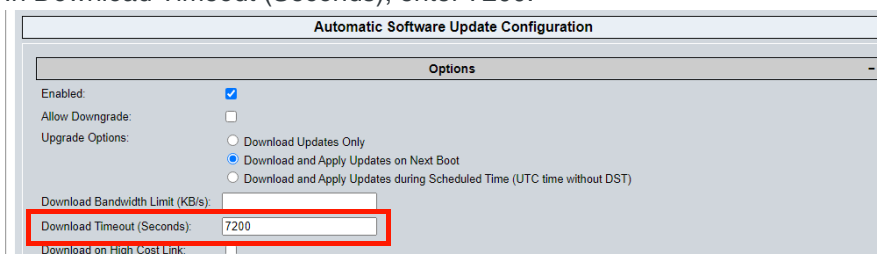
1. Go to General > Auto Software Updates.
2. Sierra Wireless recommends setting the download timeout value to 7200 s, to ensure the download completes in one attempt. (Otherwise, if the download times out, it will resume at the next opportunity — for example, when the active link changes, the next scheduled update window, when the device reboots, etc.)

In Download Timeout (Seconds), enter 7200.

Automatic Software Update Configuration
