MGOS 4.4.2

RELEASE NOTES

MGOS 4.4.2 is a general release for MG90 routers (4G and 5G variants).

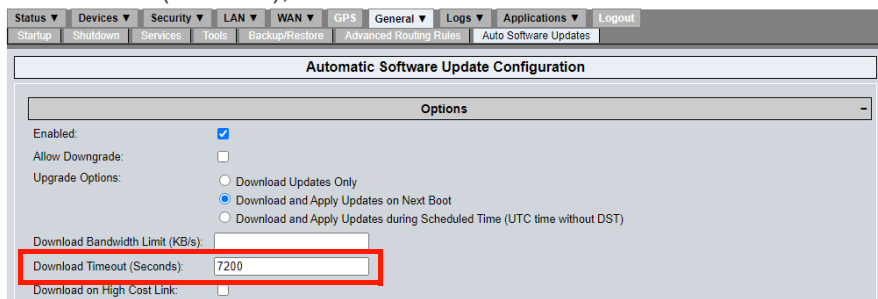
- **Upgrade recommendation**—Before using AMM to upgrade to MGOS 4.4.2, Sierra Wireless recommends setting the download timeout value to 7200 s, to ensure the download completes in one attempt. (Otherwise, if the download times out, it will resume at the next opportunity—for example, when the active link changes, the next scheduled update window, when the device reboots, etc.)
 - a. In MGOS, go to General > Auto Software Updates.

b. In Download Timeout (Seconds), enter 7200.
